TECHNICAL NOTE

D-101

ROUGH-WATER DITCHING INVESTIGATION OF A MODEL OF A JET
TRANSPORT WITH THE LANDING GEAR EXTENDED AND
WITH VARIOUS DITCHING AIDS

By William C. Thompson

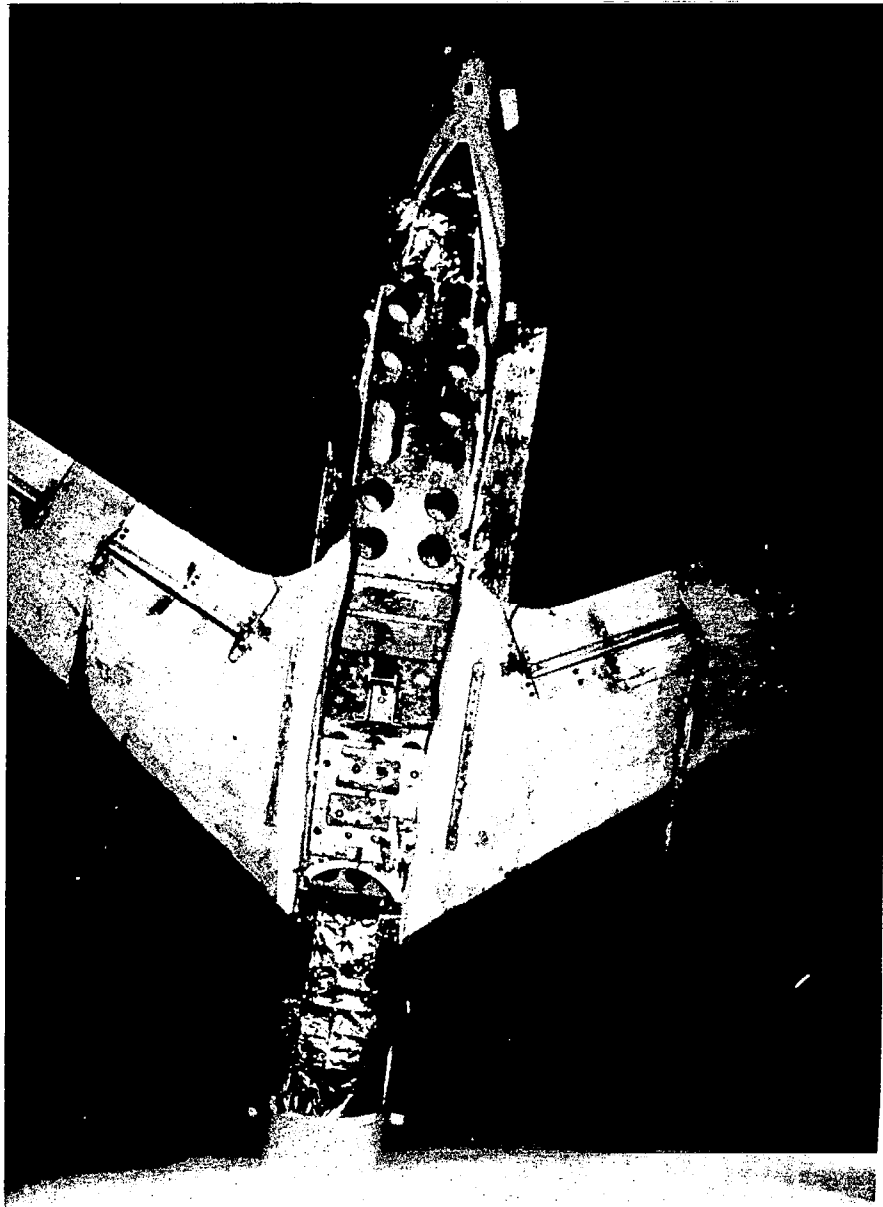
When the model was ditched in calm water with the landing gear retracted (ref. 1), about one-half of the scale-strength bottom was torn away. When the model was ditched in waves with the landing gear retracted, practically all of the scale-strength fuselage bottom was torn away as shown in figure 9(a). A full-scale airplane sustaining

such damage would most likely sink within a very short time. Ditchings into the 4-foot by 120-foot waves resulted in a maximum normal acceleration of 4g. (See table I.) The model did not penetrate the waves deeply but tended to bounce from crest to crest until considerable forward speed was lost; then, the model followed the wave contours for the remainder of the run. The total length of landing run was about 600 feet, full scale. The maximum normal acceleration in the 4-foot by 200-foot waves was about 8g as the model ploughed into the forward slope of the waves. The distance from initial water contact until the forward motion of the model stopped was about 550 feet, full scale.

(a) Landing gear retracted; no ditching aids. Most of bottom torn away. L-59-3089

Figure 9.- Typical damage to the scale-strength fuselage bottom during rough-water ditchings.

On the basis of these model tests, it appears that if the main gear fails there is little choice between ditching with the gear extended or retracted; but, if the main gear does not fail, a more dangerous behavior results. Therefore, it is recommended that the gear remain retracted in a ditching.

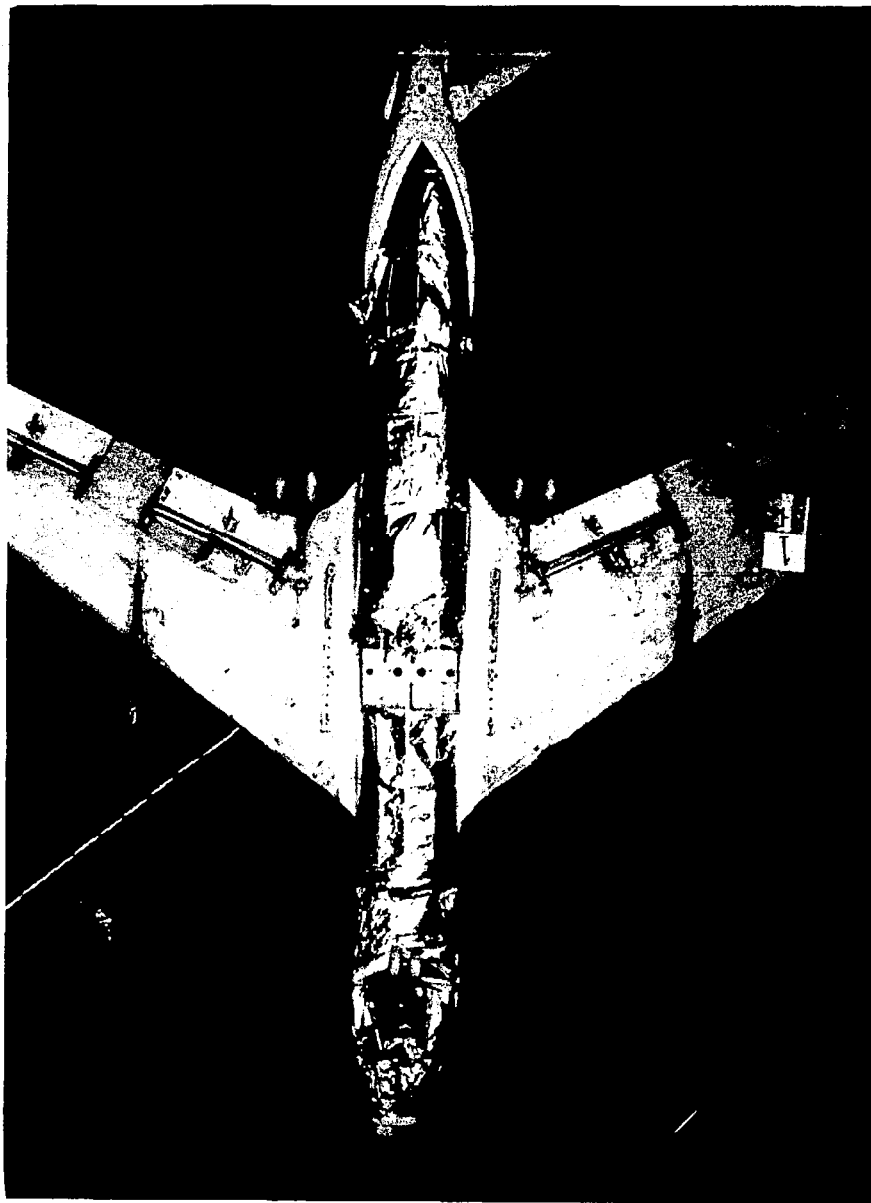
Main gear.- The scale-strength attachments for the main landing gear were of such strength that sometimes they failed and sometimes they did not. When the main gear failed, the model ran deeply and there was appreciable damage to the scale-strength fuselage bottom. (See fig. 9(b).) The maximum normal acceleration was about 6g and the maximum longitudinal deceleration was about $5\frac{1}{2}$ g. The total length of the landing run was about 450 feet. These results when compared with those for all wheels retracted indicate less but still appreciable damage, about 2g less normal acceleration and a landing run about 100 feet shorter. When the main gear did not fail, the model usually dived and there was a large hole torn in the bottom of the nose section of the fuselage as shown in figure 9(c). However, such damage accompanied by a diving motion would most likely cause extremely rapid flooding of the entire fuselage. There was little difference in behavior or damage whether the model was ditched in calm water or waves 4 feet high. (See table I.)

L-59-3090
(b) Landing gear down; all failed; appreciable damage throughout the length of the fuselage. .

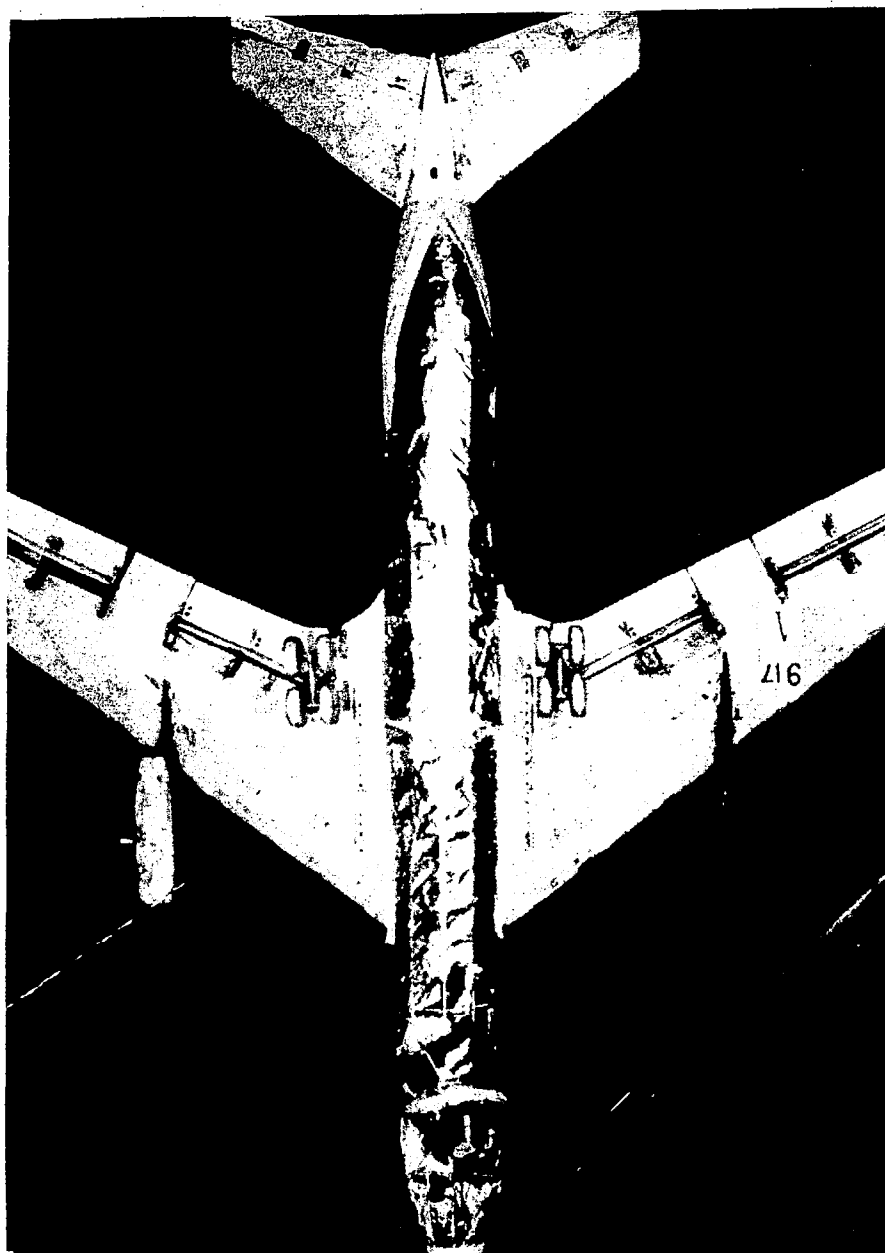
(c) Landing gear down; main gear did not fail. Moderate damage in nose section.

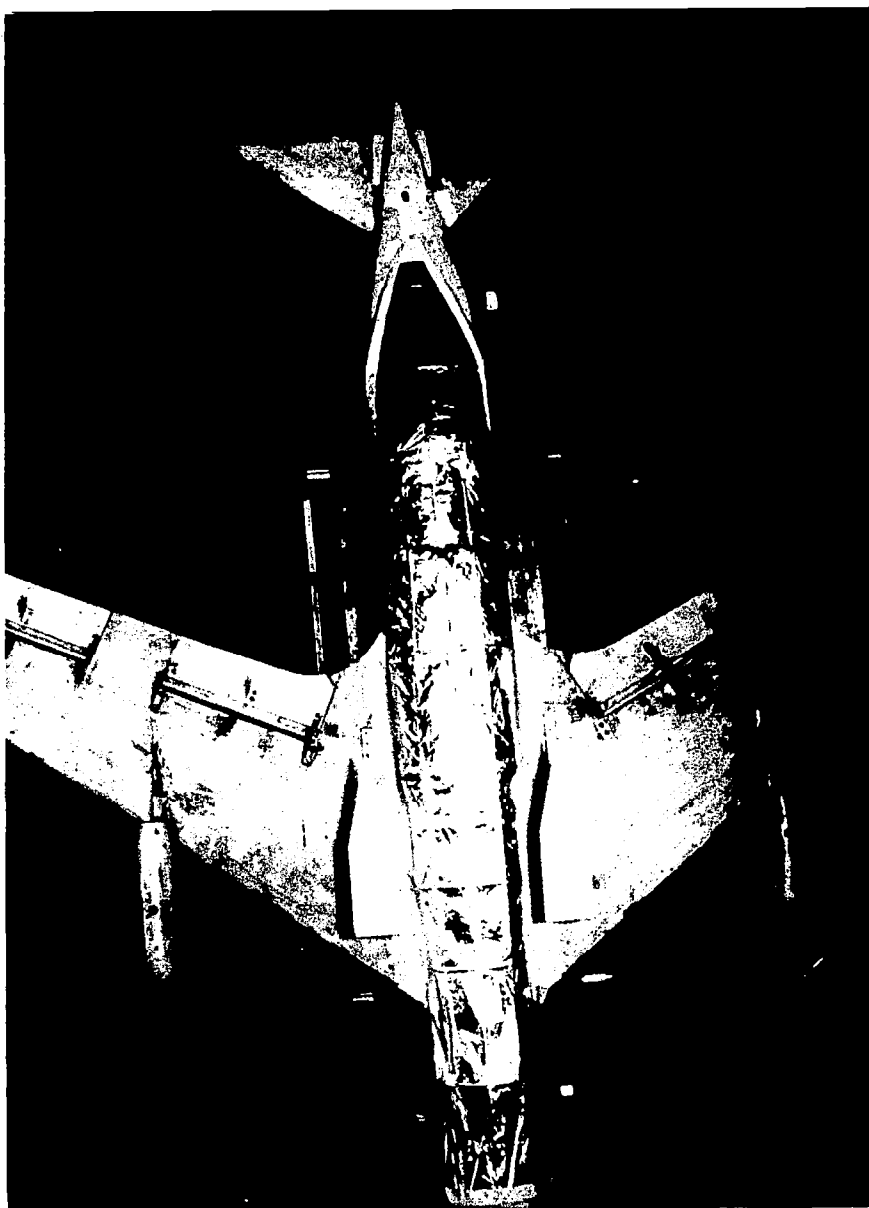
When the model with the twin hydro-skis (fig. 7(a)) having a loading of 2,500 pounds per square foot was ditched into waves 4 feet high, the result was a fairly smooth run with very little damage to the fuselage

bottom as may be seen in figure 9(d). Ditchings in either wave condition resulted in a maximum normal acceleration of about $3\frac{1}{2}g$ and a total length of landing run of about 1,280 feet (see table II). With the smaller twin hydro-skis which had a loading of 4,400 pounds per square foot, the model trimmed down, ran smoothly, and ran deeply. There was moderate damage to the midportion of the scale-strength fuselage bottom (fig. 9(e)). The maximum normal acceleration was about $3\frac{1}{2}g$, which was the same as was obtained with the larger hydro-skis. However, the total length of landing run was about 600 feet, which was about one-half that for the larger hydro-skis.

L-59-3092
(d) Twin hydro-skis (loading of 2,500 pounds per square foot). Very little damage.

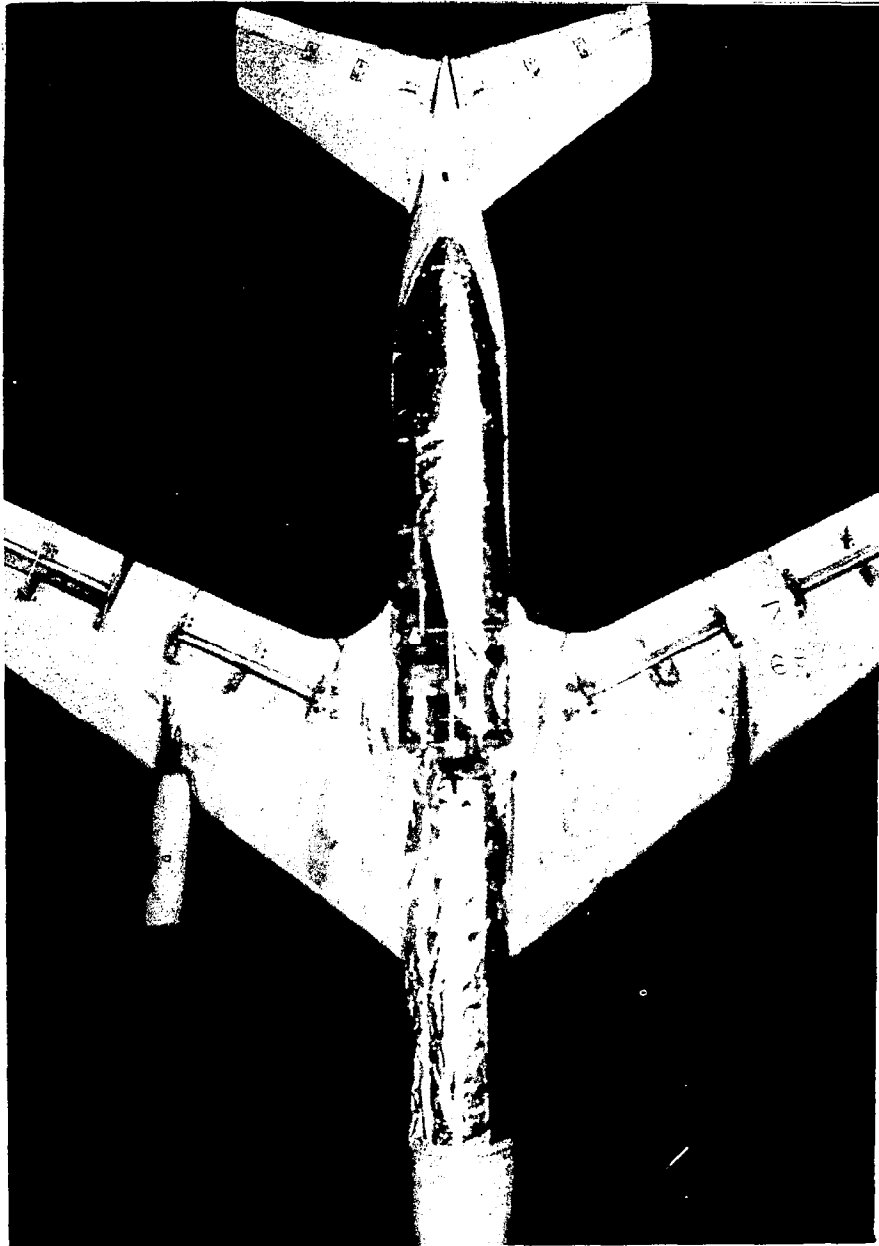
(e) Twin hydro-skis (loading of 4,400 pounds per square foot). Moderate damage to midportion of fuselage bottom. L-59-3093

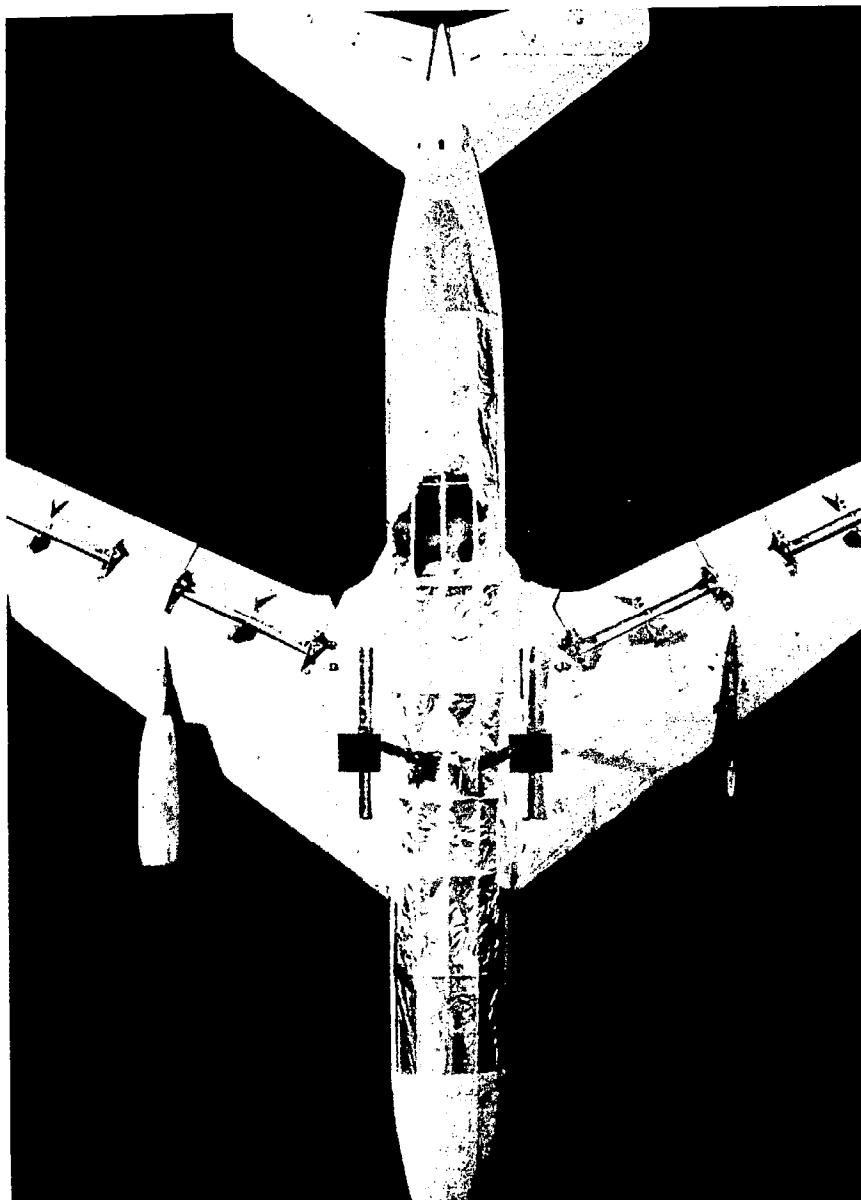
Tests with the larger twin-hydrofoil installation (fig. 7(c)) having a loading of 7,500 pounds per square foot resulted in a fairly rough ditching since the hydrofoils did not penetrate the waves but rather bounced along the crests until most of the forward velocity was lost. The total length of landing run was about 1,160 feet and the maximum normal acceleration was $6g$, which was about twice that obtained with any of the other ditching aids. There was moderate damage to the fuselage bottom just aft of the wing as may be seen in figure 9(f).

L-59-3094
(f) Twin hydrofoils (loading of 7,500 pounds per square foot). Moderate damage to fuselage just aft of wing.

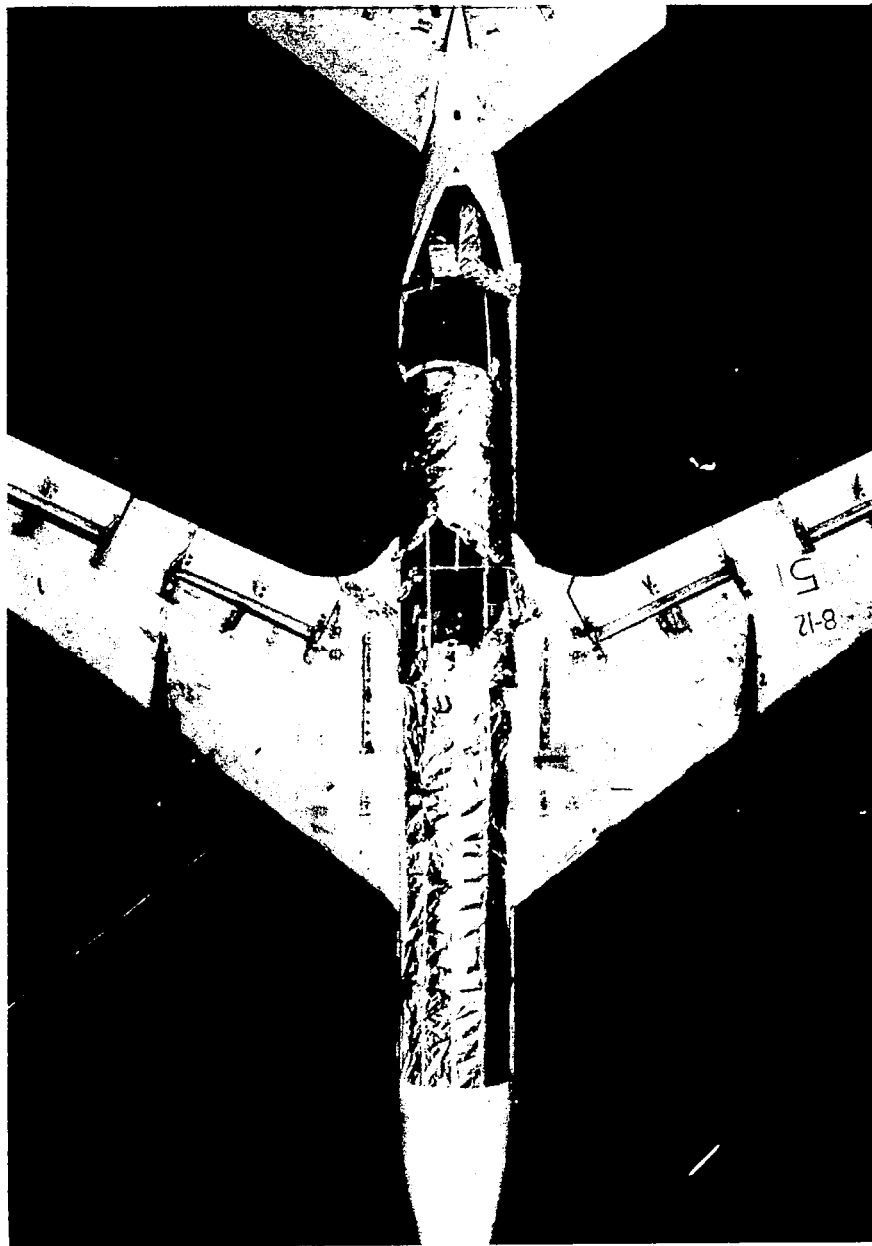
Tests with the smaller twin-hydrofoil installation having a loading of 13,000 pounds per square foot resulted in fairly smooth runs with the hydrofoils penetrating the waves. There was more damage to the rear portion of the fuselage bottom than occurred with the larger hydrofoils (fig. 9(g)). The maximum normal acceleration was $3g$ in a total length of landing run of about 900 feet.

(g) Twin hydrofoils (loading of 13,000 pounds per square foot). Appreciable damage to rear part of fuselage bottom.

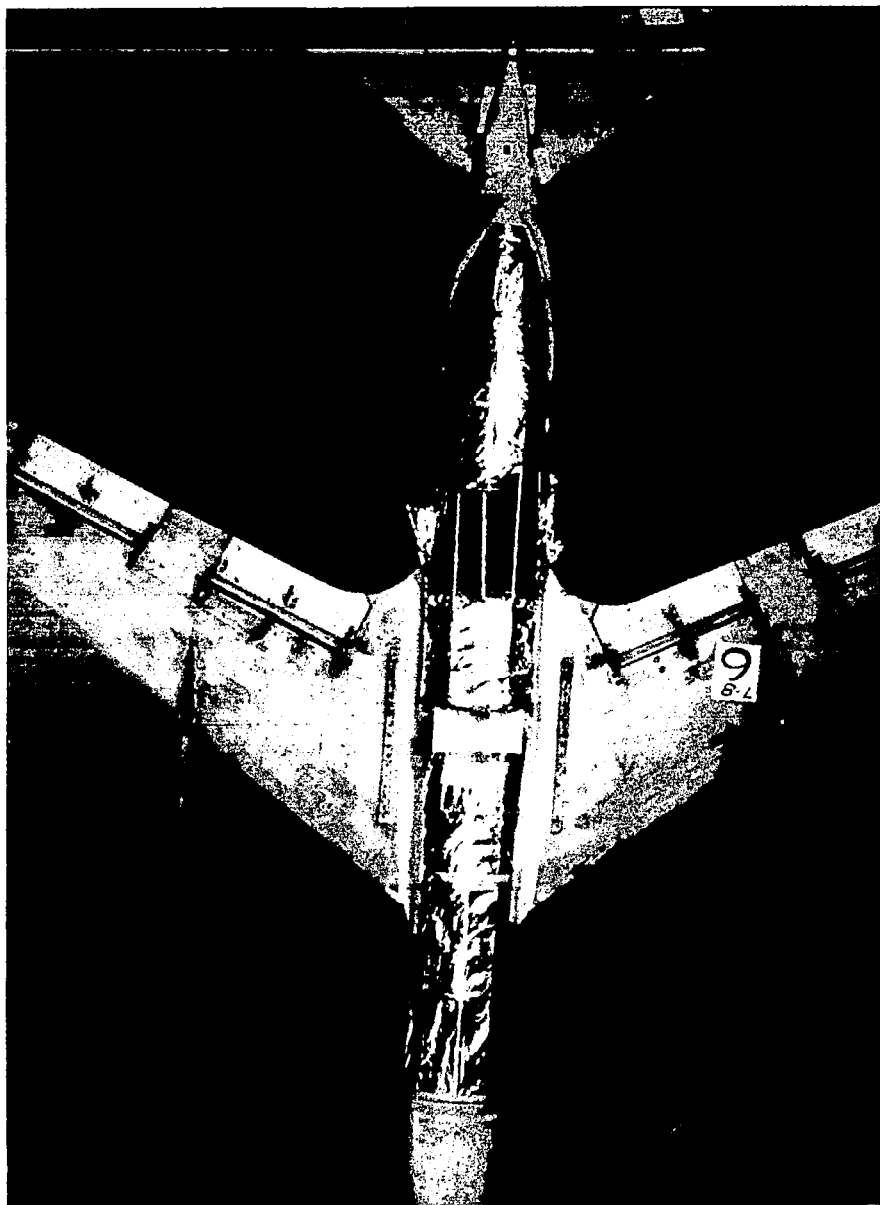
When the model was ditched with the single-hydrofoil installation (fig. 7(e)), the hydrofoil penetrated the wave crests and ran smoothly. Damage to the scale-strength fuselage bottom consisted of a section of skin about 8 feet square torn away just aft of the wing. This damage was considered moderate since the supporting structure remained intact and only the skin was torn away. Figure 9(h) shows typical damage that occurred. The maximum normal acceleration was about $3\frac{1}{2}g$ and the total length of landing run was about 1,100 feet.

(h) Single hydrofoil (loading of 8,300 pounds per square foot). Moderate damage to fuselage just aft of wing. L-59-3096
